CASE STUDY 02 • EXAMPLE

# Hall interior heat map – overheating cable connection (example)

A loose terminal dissipates a few watts – yet it reads 78 °C on a thermogram. This example shows what an early warning is good for, and what it is not.

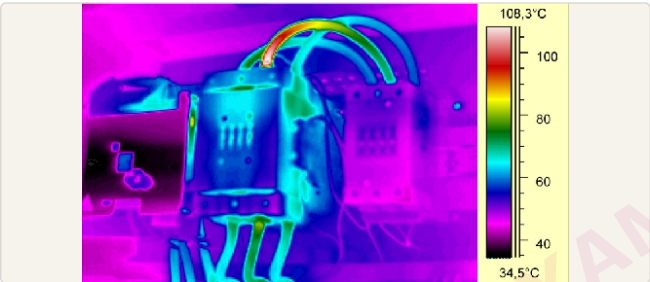
Sönke Krüll, „Elektroschuetz”, Wikimedia Commons, CC BY 3.0 – unmodified · Contactor cable termination: ≈ 108 °C while neighbouring conductors stay at 35–60 °C.

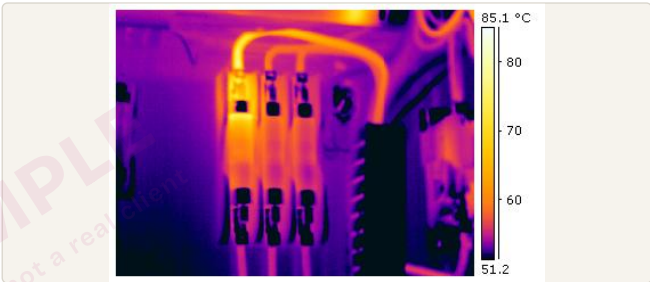
Hofflashhome, „Electrical fault”, Wikimedia Commons, CC BY-SA 3.0 – unmodified · One phase is hotter than the other two – the textbook case for comparing with similar components.
