CASE STUDY 03 • EXAMPLE

# Buried pipe – large heat leak (example)

A wetted pre-insulated hot-water line under paving reveals nothing from the surface – on a thermal image it shows as a warm band about 25 metres long. The example shows what a thermal camera can do, and what it cannot.

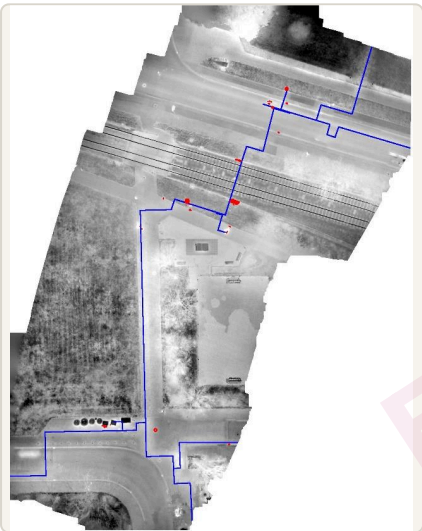
A. Sledz, J. Unger, C. Heipke, ISPRS Archives XLIII-B1-2020, Fig. 10, CC BY 4.0 – unmodified

A. Sledz, J. Unger, C. Heipke, ISPRS Archives XLIII-B1-2020, Fig. 11, CC BY 4.0 – unmodified

**UAV orthophotos (ISPRS, 2020):** researchers at Leibniz University Hannover flew infrared orthophotos over district-heating networks; in the grayscale images warmer points are brighter, the blue line is the GIS route and red blobs are anomalies flagged by an algorithm – possible leaks. A thermal anomaly alone does not prove a leak: it needs verification. **Heated pavement:** intentional heating, not a leak; it shows how warm pipes under a surface appear on a thermogram.

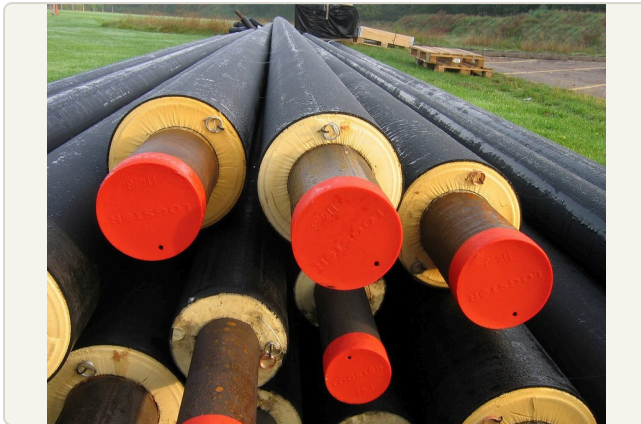
Mike1024, „Pre-installation insulated underground pipes for district heating”, Wikimedia Commons, public domain – resized · Anatomy of a pre-insulated pipe: water in the foam multiplies the heat emission.

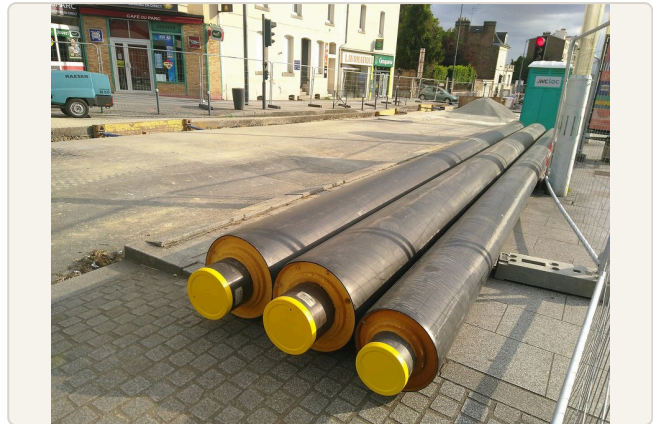
Abujoy, Wikimedia Commons, CC BY 4.0 – resized · In operation all of this runs below the paving – the camera sees only the effect that reaches the surface.
