CASE STUDY 01 • EXAMPLE

## Family house 3D heat map – example

This is what a 3D heat map looks like: findings sit where they really are on the model, you can walk around them, and each comes with a cause and a typical fix. The house is only an easy-to-read illustration – HőKép3D works with business clients.

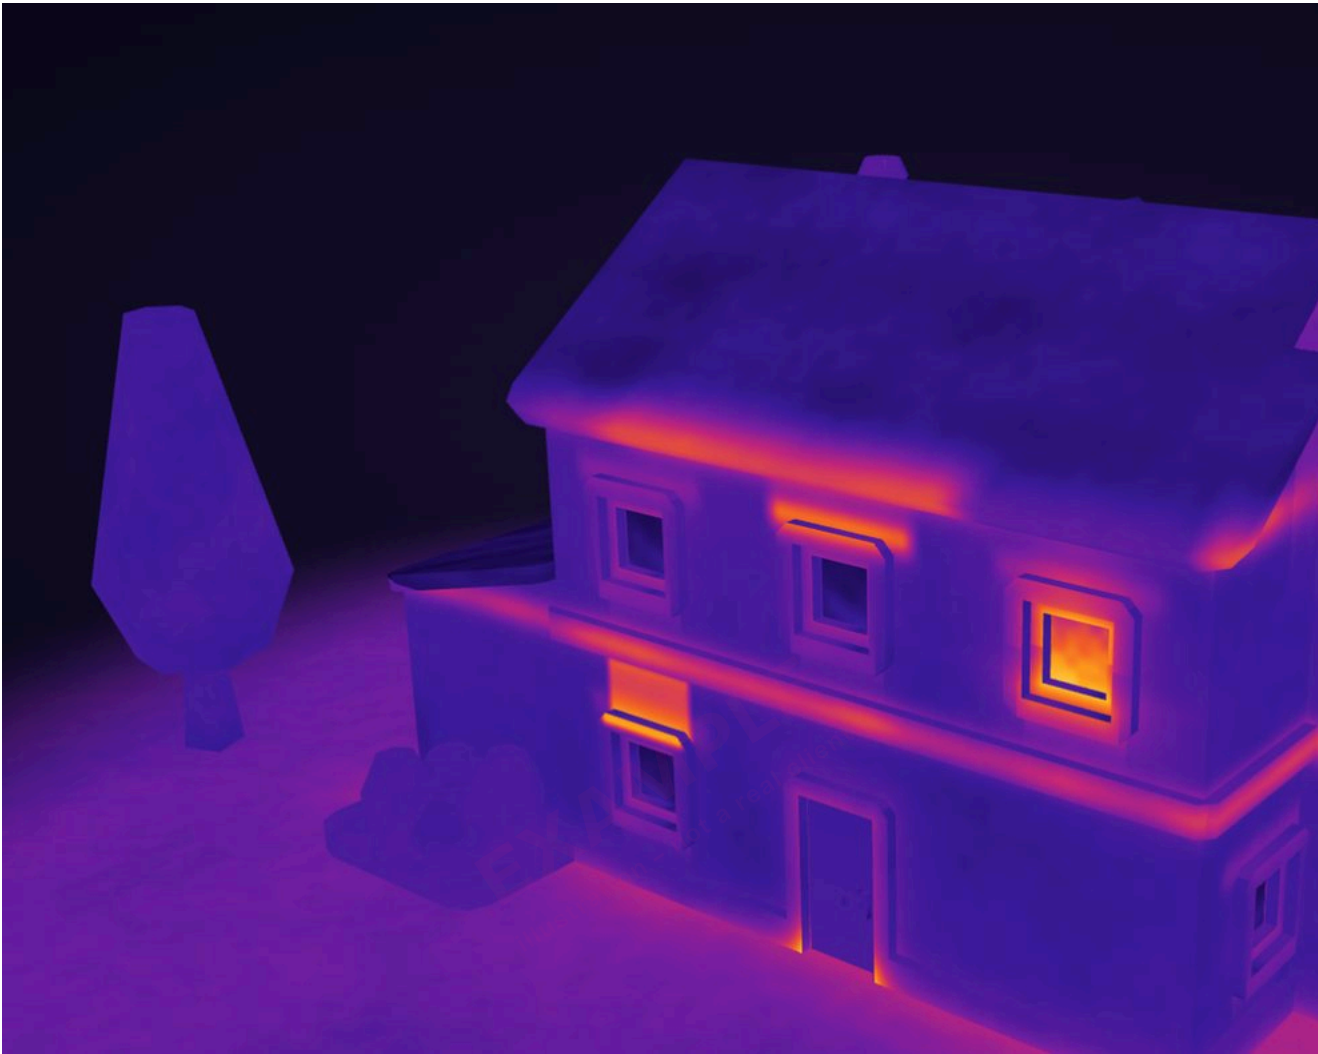
Simulated temperature field on the “City Kit (Suburban) 2.0” 3D model – Kenney (kenney.nl), CC0 1.0. The temperature field is HőKép3D’s own simplified simulation (outdoor 0 °C, indoor 20 °C, night, no wind).

A thermal image shows one plane at one moment; a facility survey produces dozens. A 3D heat map projects them onto one model that follows the real geometry, so findings are tied to a place and to dimensions.
